# Portage Creek Sediment Remediation Project Kalamazoo, Michigan

Pre-Sediment Removal Structure Feature Assessment  
Removal Areas SA1-A, SA1-B and SA1-C

**FLEIS & VANDENBRINK  
ENGINEERING, INC.**

F&V Project Number: 809930  
May, 2013 (Updated June, 2013)

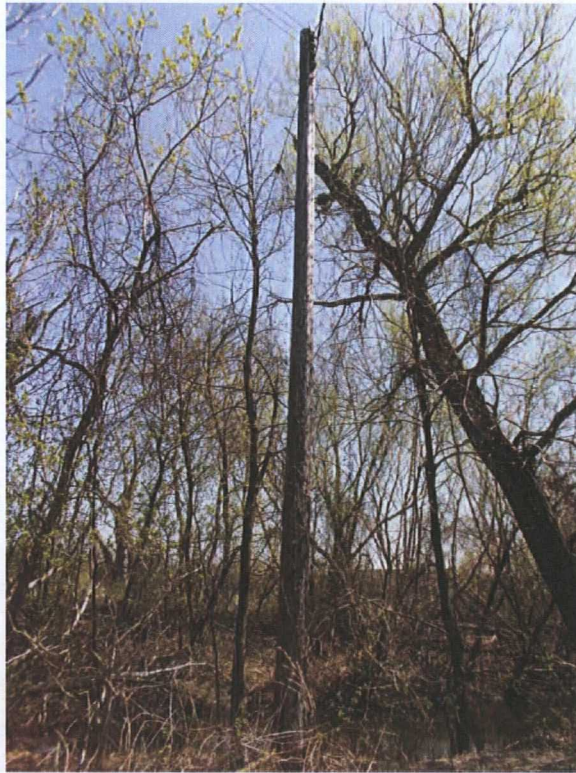
View of the pole and tangle guy looking east

- The utility company should be notified of the impacted guy wire, so that repairs can be made to stabilize the pole prior to sediment removal operations.
- Sediment should not be removed within the 1:1 influence area of the pole or guy anchor unless the pole is supported during the work.
- Construction fencing or similar means should be used to identify the pole and guy to operators and drivers during the work.

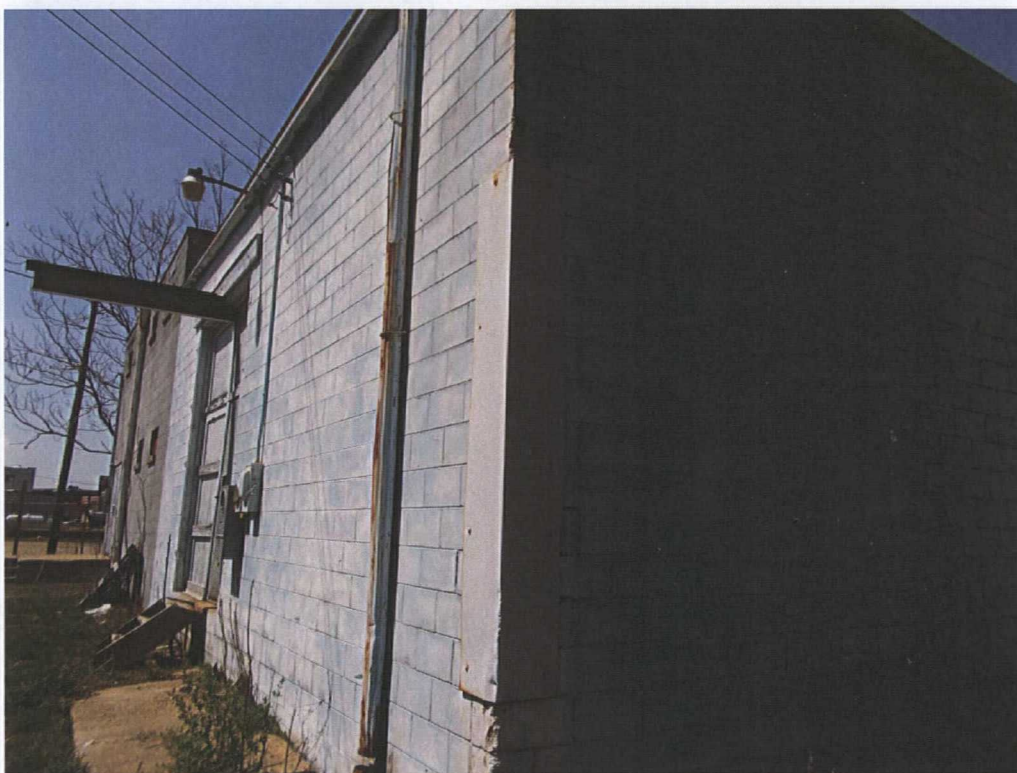
Steel reinforcing angle on the southeast corner of the building

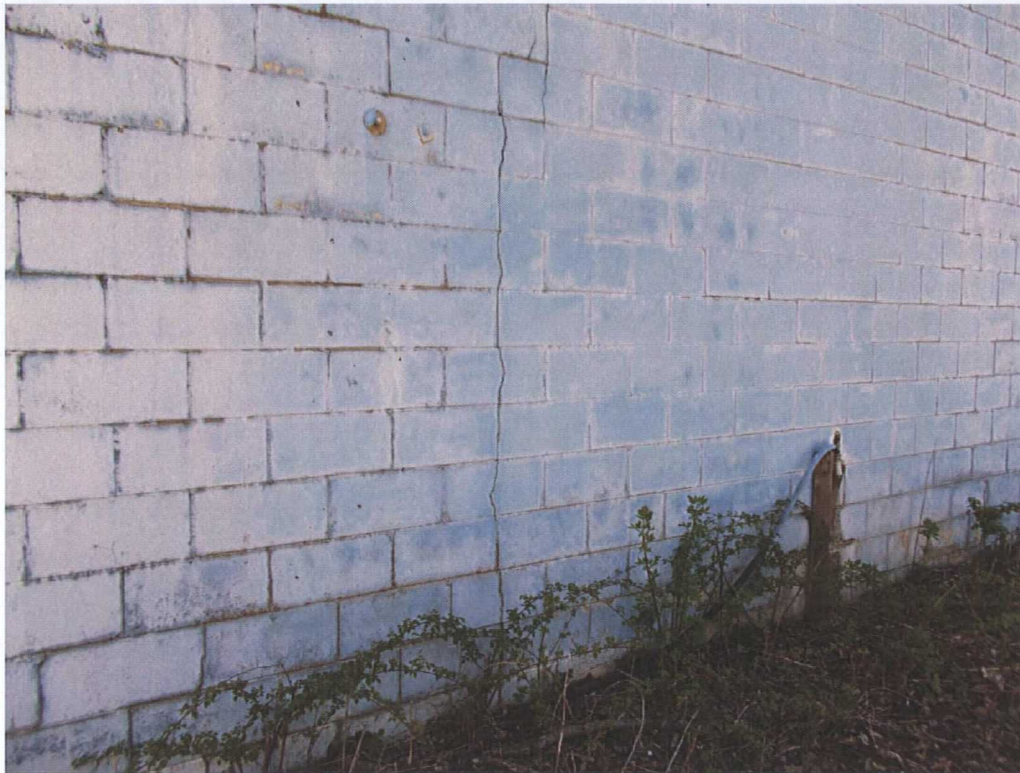
- The CMU has moderate vertical and step cracking.
- A severe vertical crack was noted at the joint between sections of the building.

Vertical cracking in the CMU

- The building appears to be outside the influence of the sediment removal. Operators and drivers should use due care when working around the building to avoid damage from equipment.

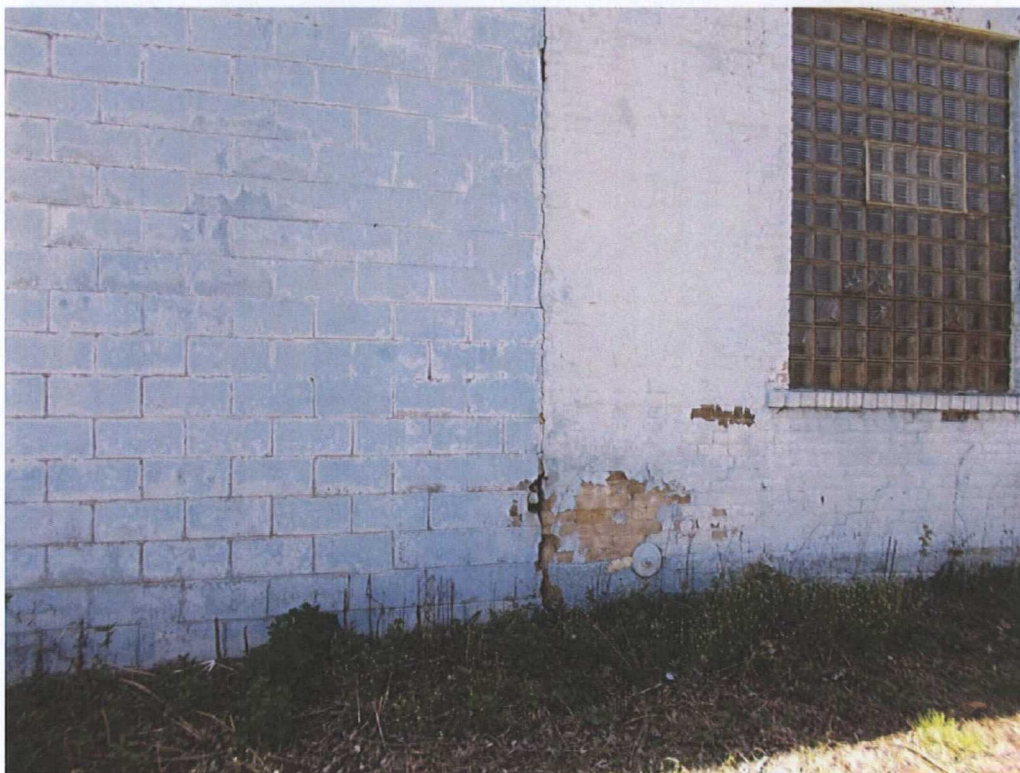
Severe vertical crack at joint between building sections

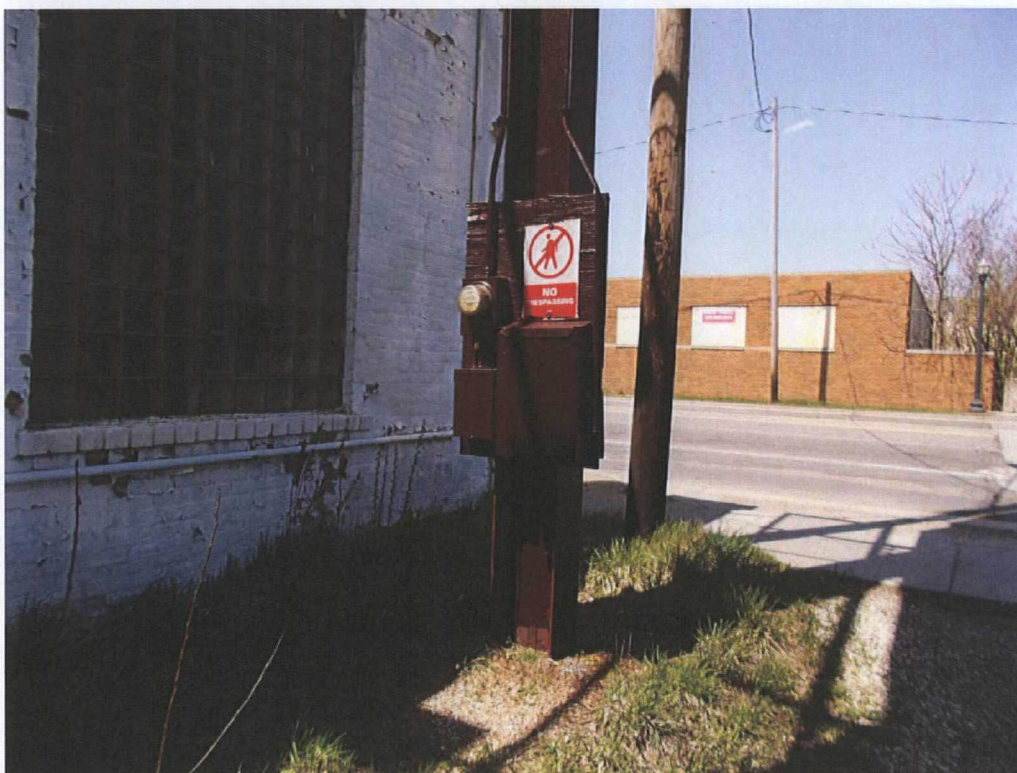
Electric service panel mounted to northernmost column

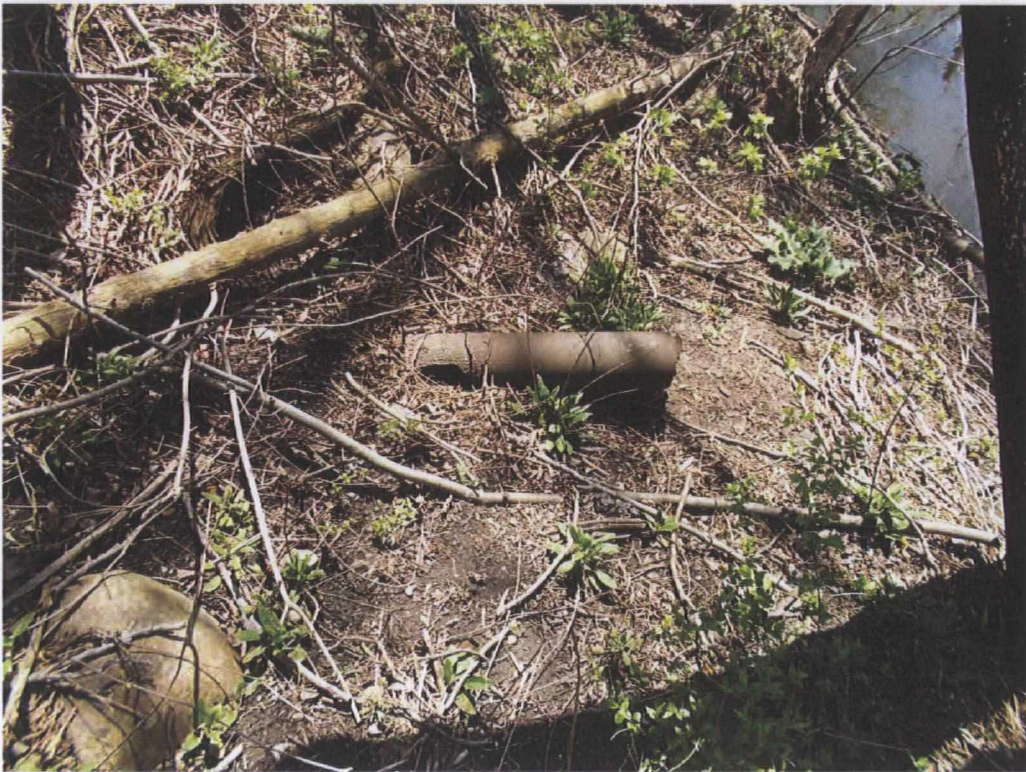
- The pipe is severely deteriorated. The end of the pipe has complete section loss around much of its circumference and there is a large hole in the north side 2' from the end.

View of the structure looking south, showing large hole in north side

- It is likely that the pipe can be removed or cut off at grade and abandoned if it conflicts with sediment removal operations.

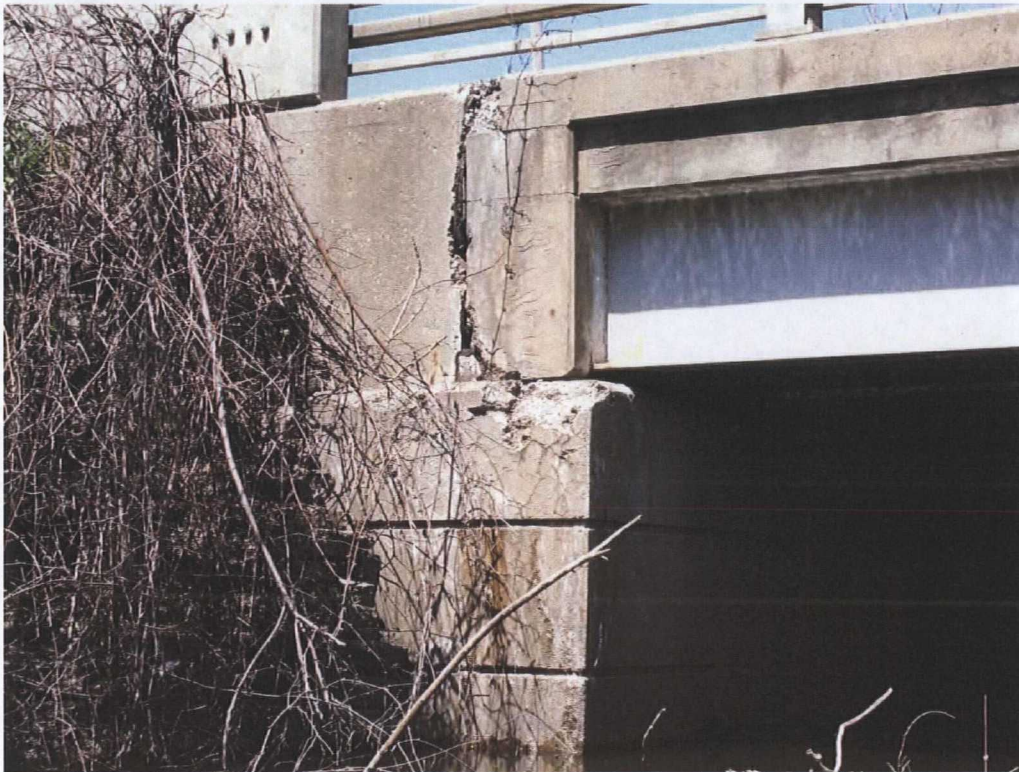
- The channel spans from abutment to abutment. There is no bank intact at the structure.
- The corners of the abutments have cracking with efflorescence and spalling.

Cracking with efflorescence and spalling on southwest abutment

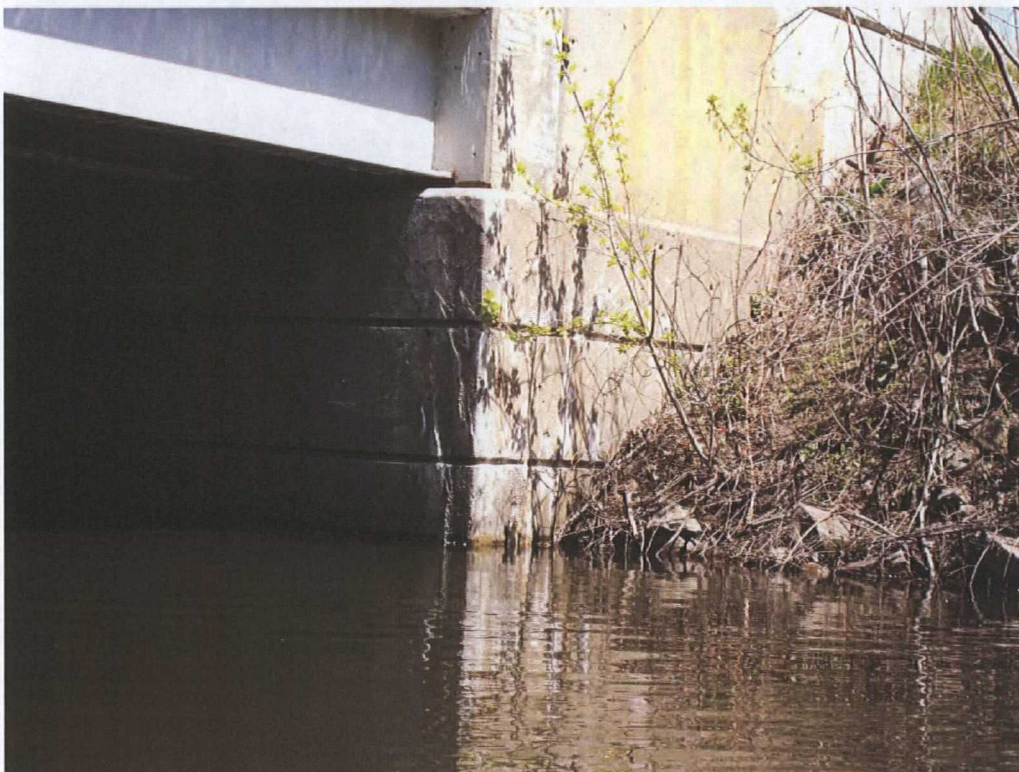
Cracking and efflorescence on southeast abutment

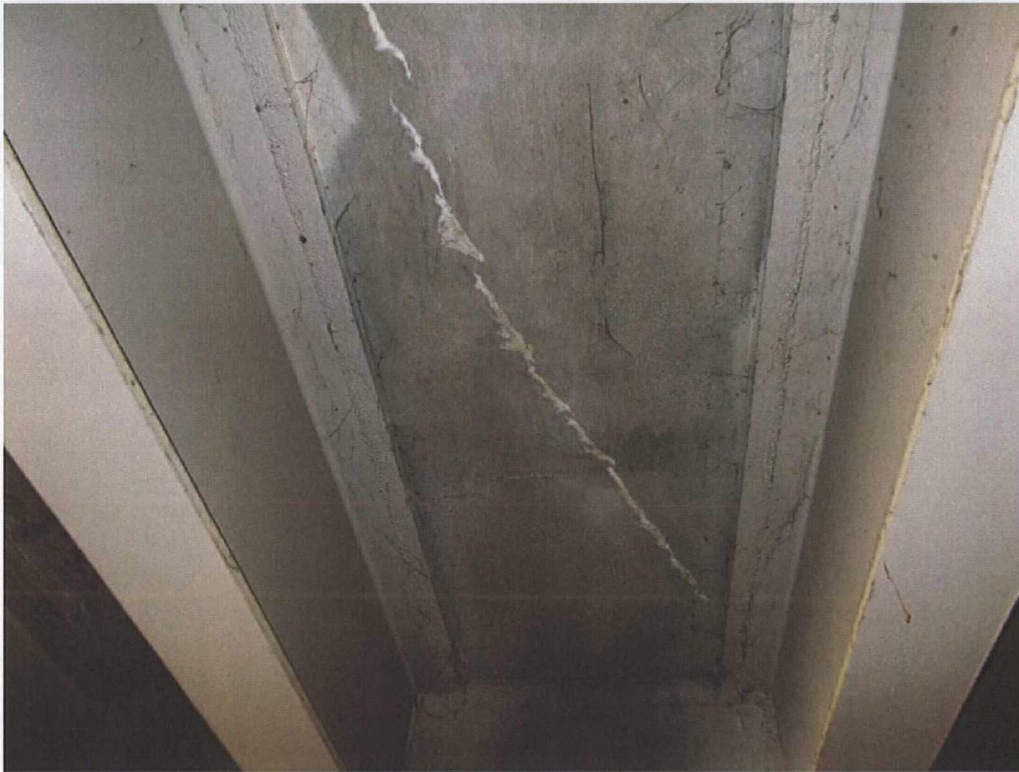
- The deck soffit has scattered hairline longitudinal cracking with efflorescence.
- Scattered riprap was detected along the abutments below the waterline.

Hairline cracking with efflorescence on bottom of deck

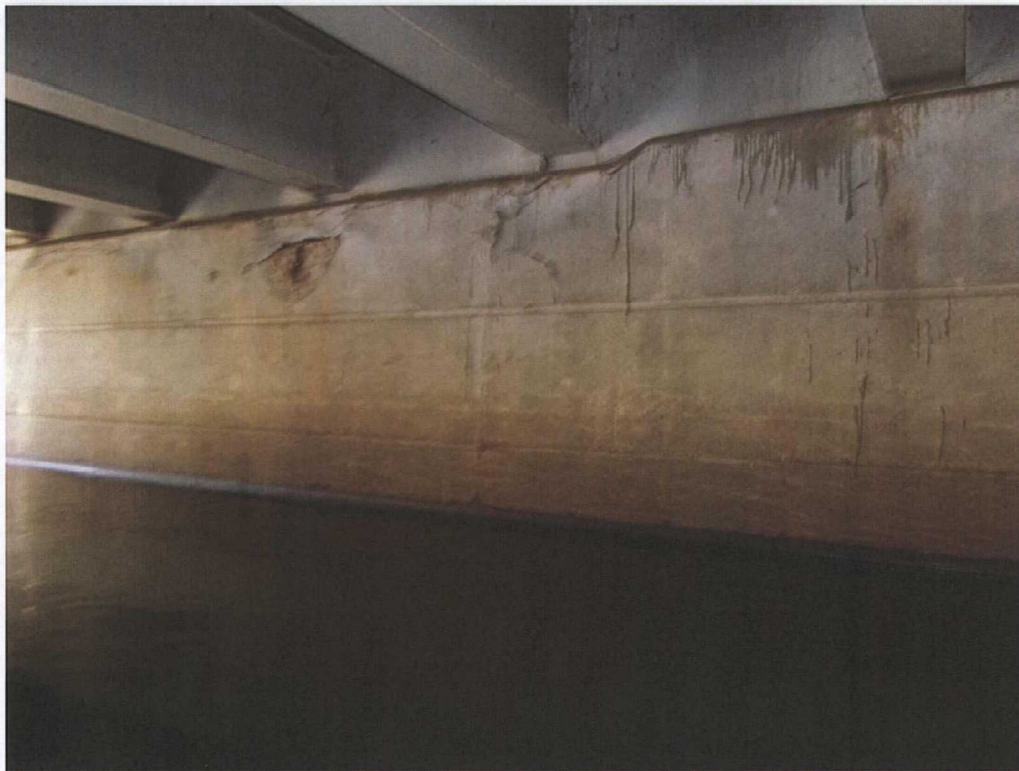
- Moderate slope/bank erosion was noted in all 4 quadrants, severe in the northwest.
- The abutments have minor to moderate vertical cracking scattered throughout. There is an isolated spall to steel beneath beam 4S on in the southwest. The top of abutment is cracked and delaminated between beams 1S and 5S in the southwest.

Cracking and delamination on top of abutment in southwest

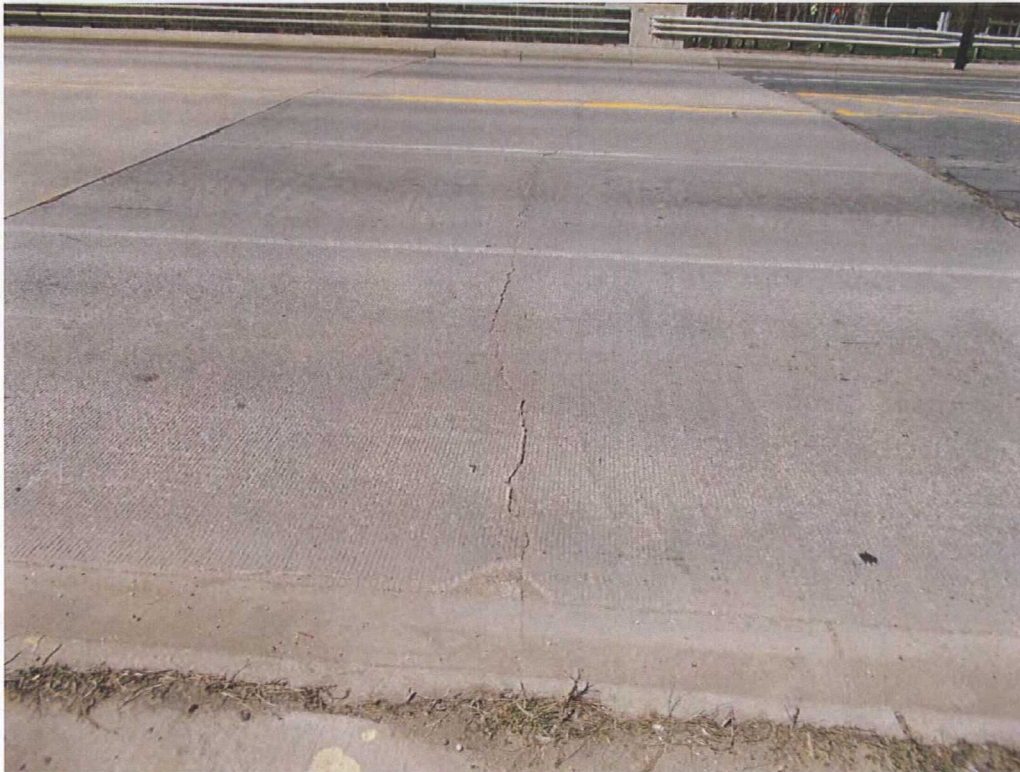
- Scattered woody debris was noted in the channel.
- The concrete approaches have severe transverse cracking.
- ASR-type cracking was noted in the railing end walls.

Transverse cracking in the east concrete approach slab

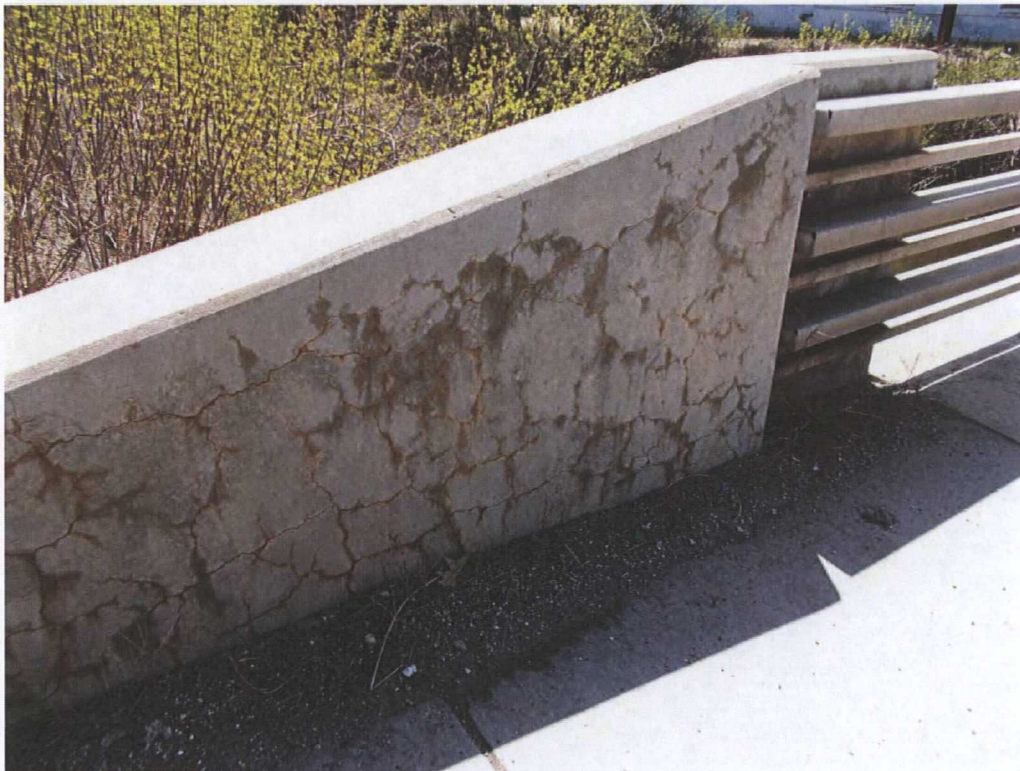
ASR-type cracking in the southeast end wall

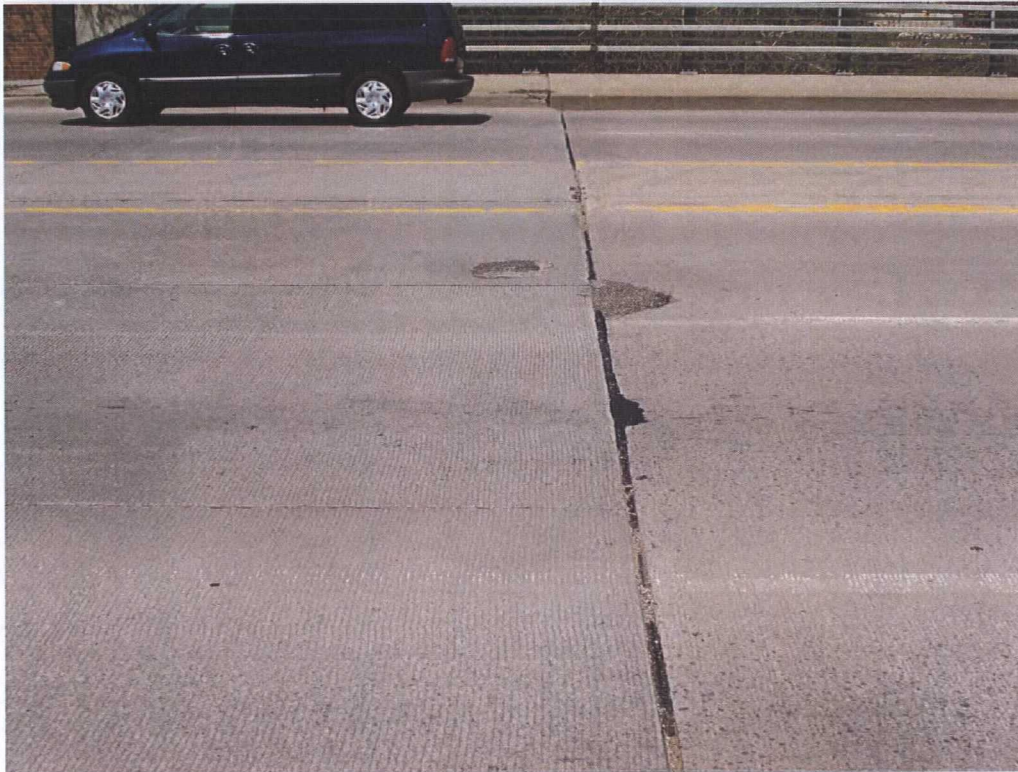
- The deck has an isolated area of spalling, approximately 12"x18" along the west reference line near centerline.
- There is a failed cable railing in the southwest.

Deck spalling along west reference line near centerline

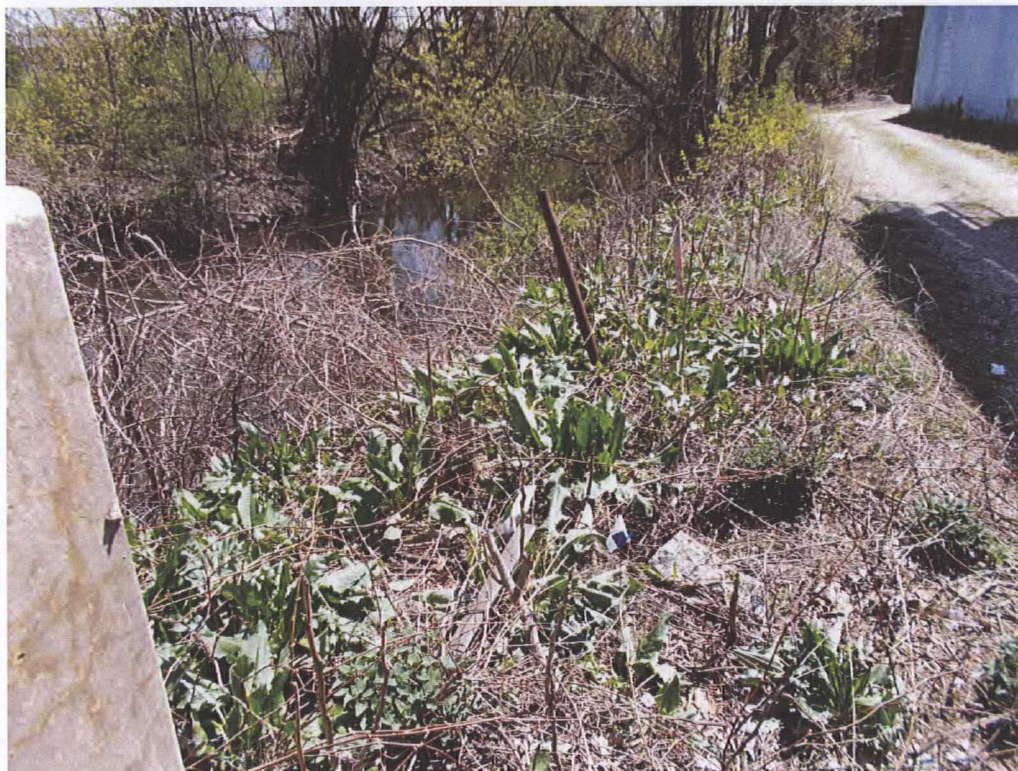
Failed cable railing in the southwest

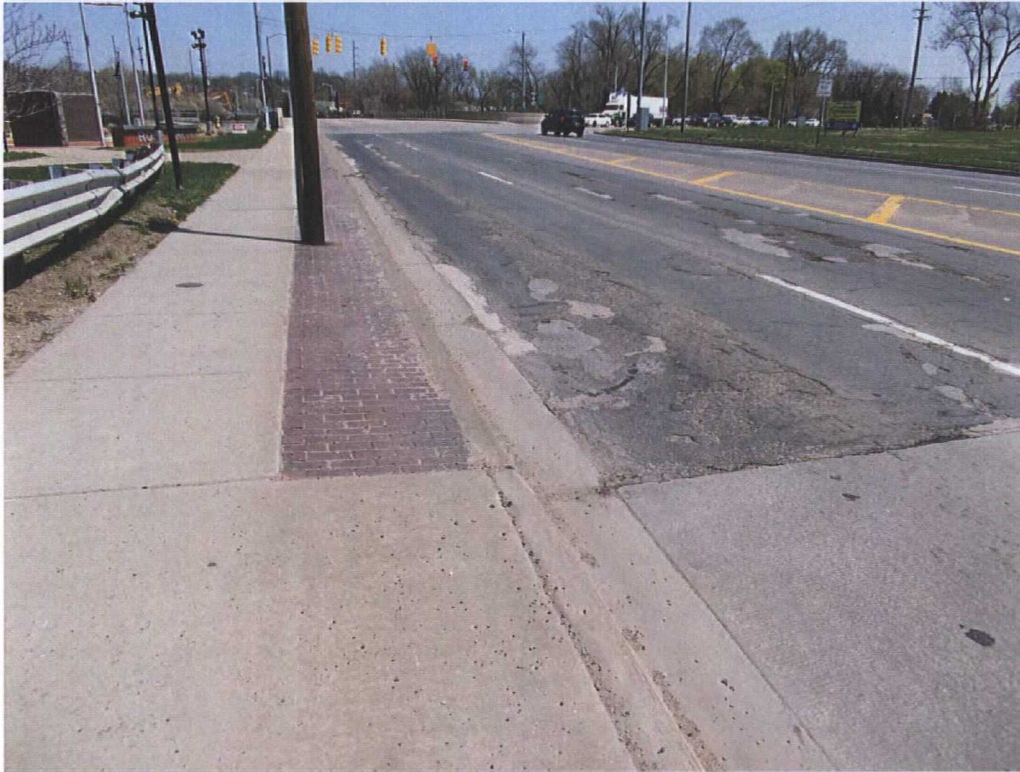
- The decorative street light in the northwest quadrant has sustained damage to its base.
- The asphalt pavement beyond the concrete approaches is severely deteriorated with significant cracking and spalling/cold patch.

Decorative pavement in the northeast and deterioration of asphalt pavement

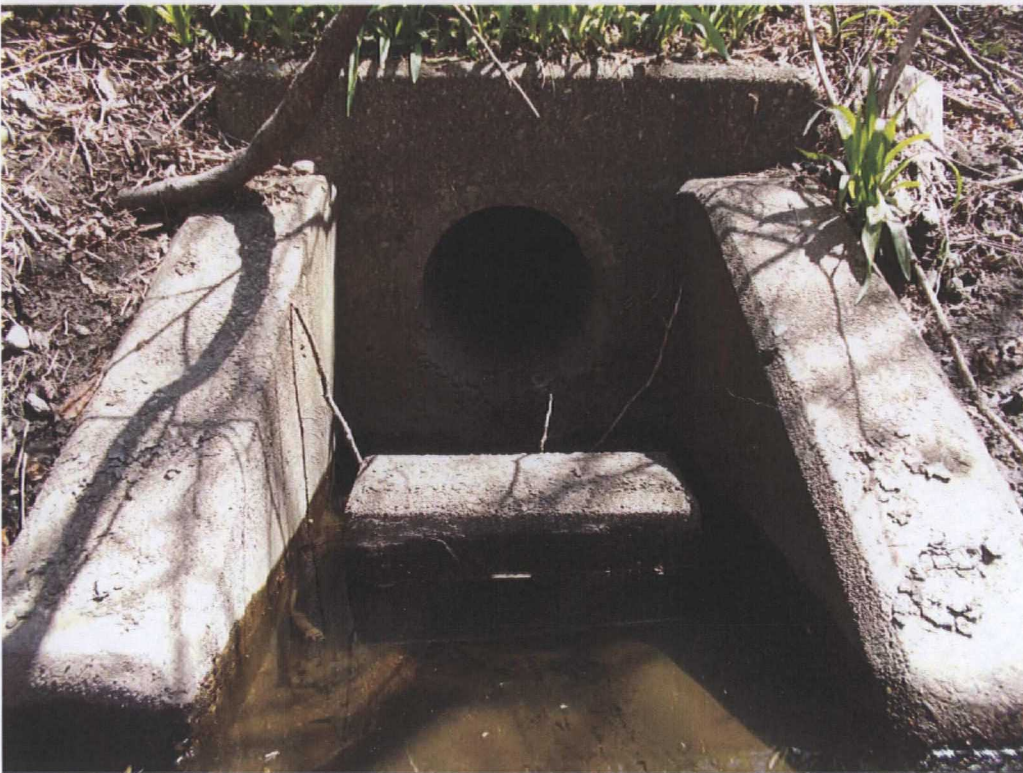
- The pipe appears to be in fair to good condition, with minor mortar cracking at the end.
- The headwall appears to be in good condition. No undermining was detected.

Close-up view of the structure

- The outlet should be isolated with a cofferdam during sediment removal. A minimum clearance of 2-3' is recommended for the cofferdam.

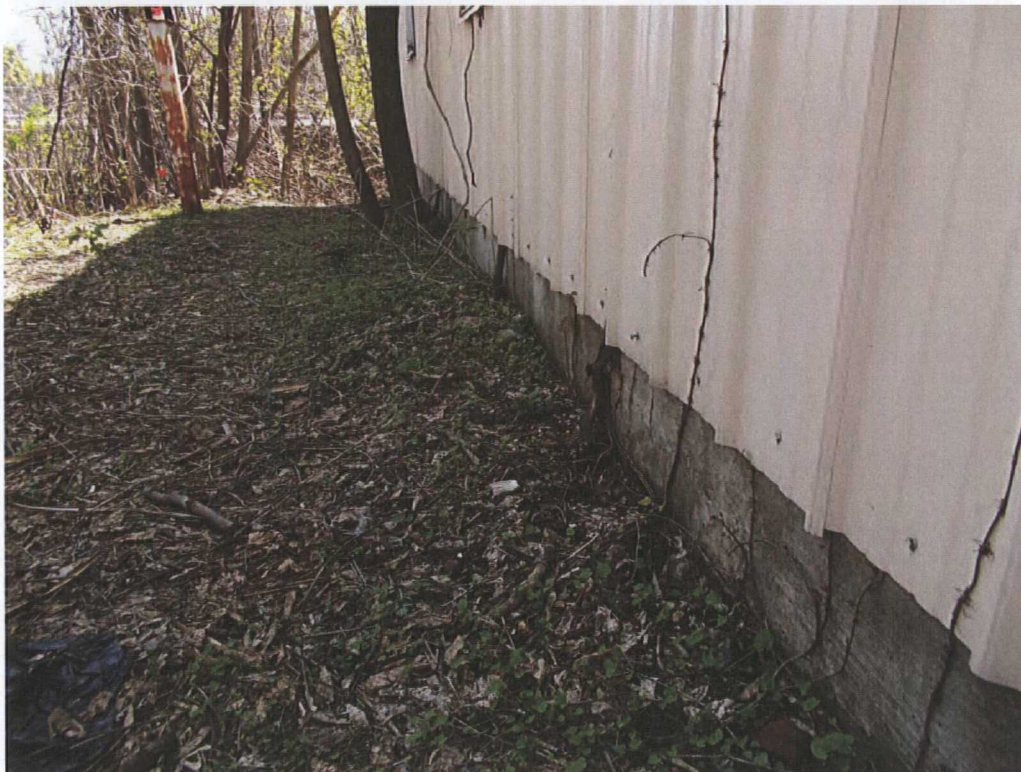
Brush growth behind aluminum siding

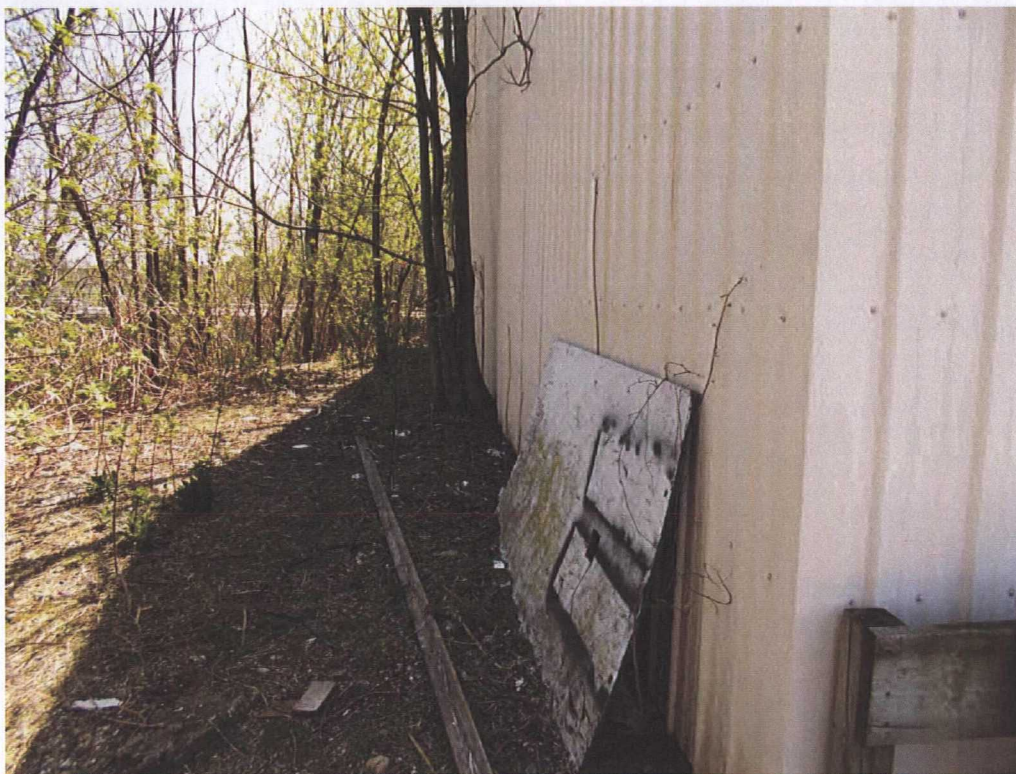
Tree growth along northeast wall

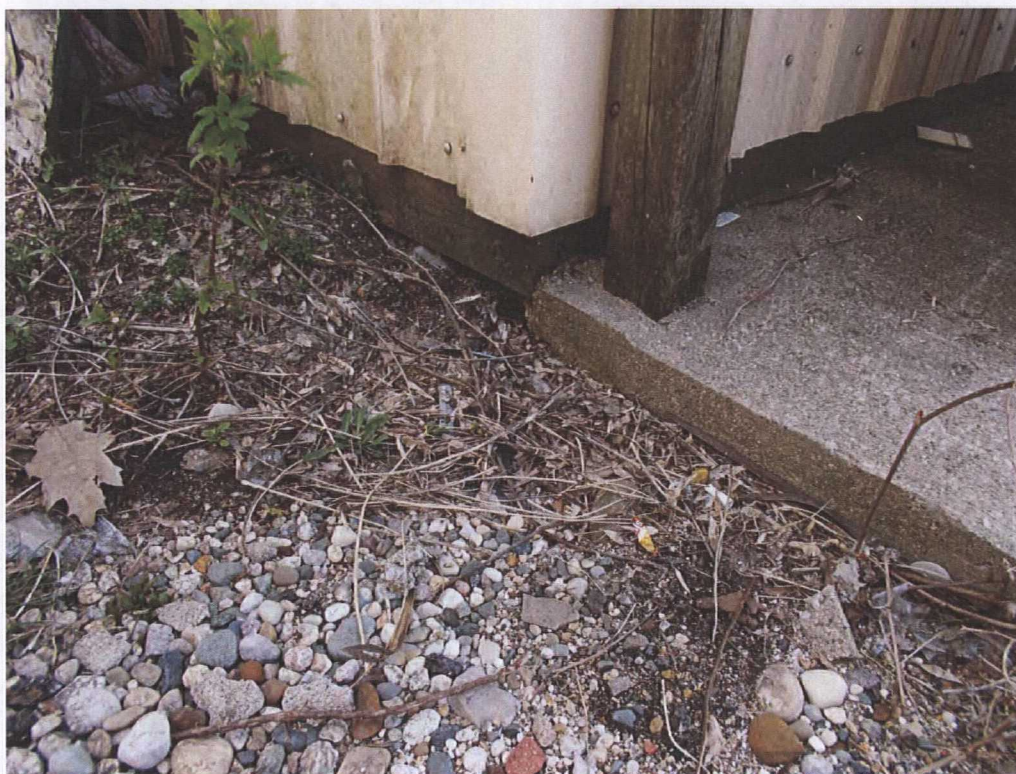
Washout around northeast corner of building

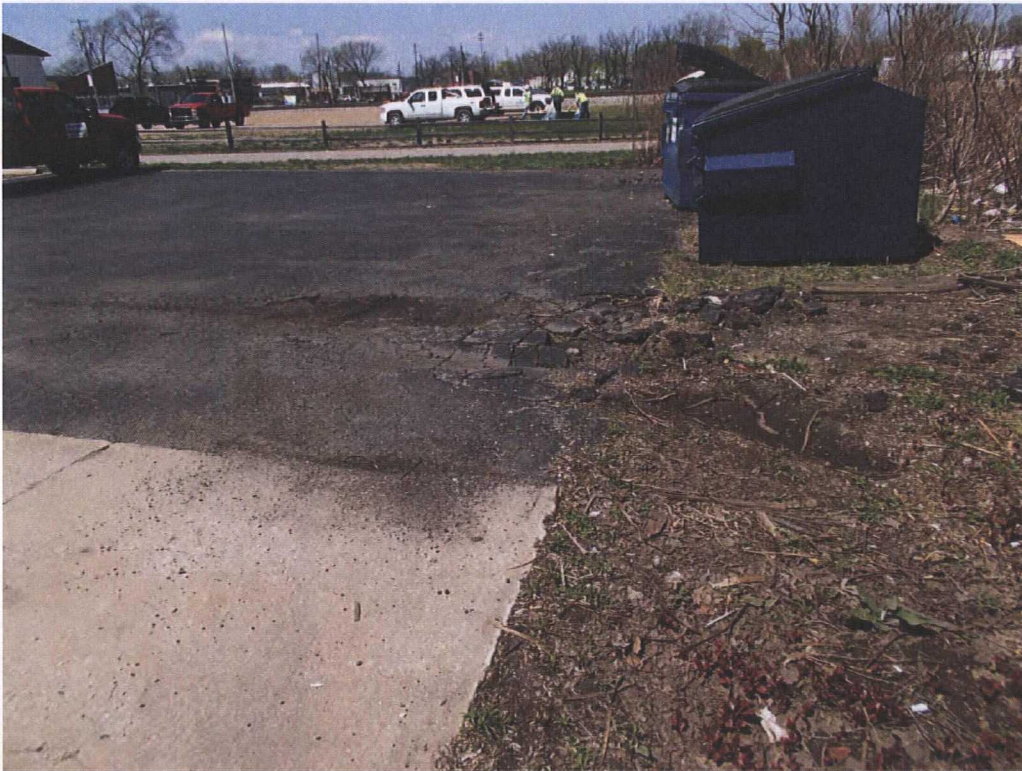
- The brick extension wall in the southeast corner has severe horizontal cracking at a mortar joint.
- The concrete foundation appears to be in fair condition.
- The aluminum siding appears to be in fair condition.
- The wood window trim is severely rotted.
- A significant amount of brush growth was noted behind the siding.
- The concrete and asphalt pavements on the north side of the building are severely deteriorated. The asphalt in particular has failed, apparently due to dumpster access.

Failure of asphalt pavement near dumpsters

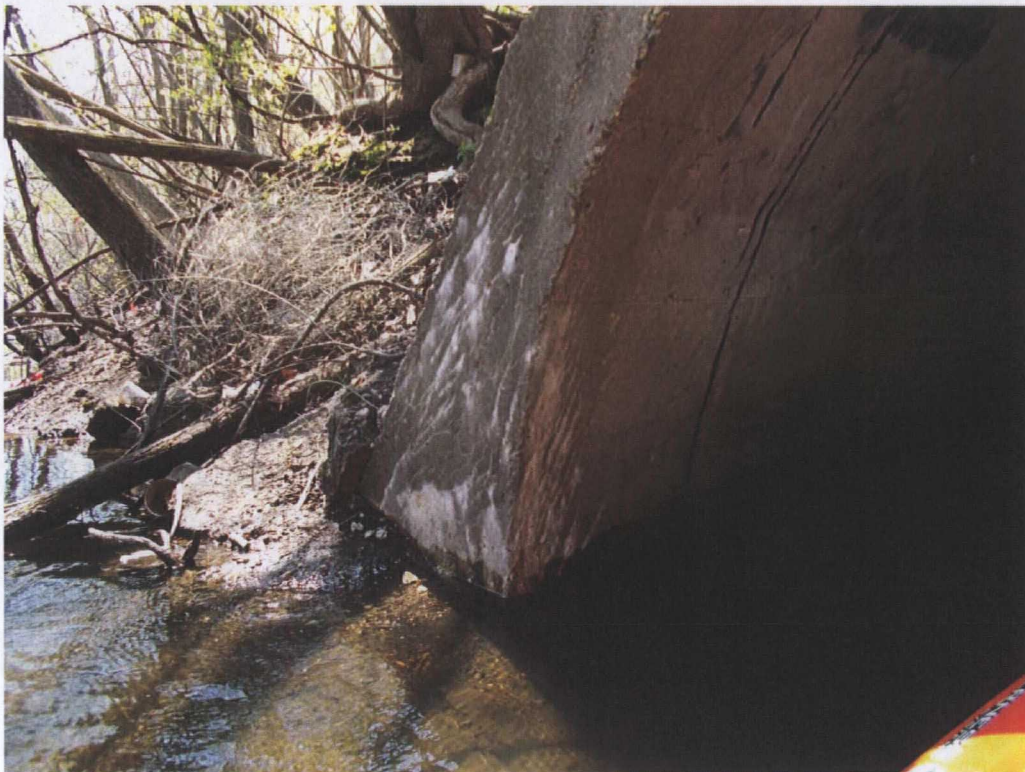
- There is a spalled area with exposed steel on the north side of the interior.
- The concrete has efflorescence and delamination along the waterline.
- Minor to moderate cracking was noted in the soffit area.
- The majority of the structure appears to be in fair condition.
- Assuming the structure is a complete circular section, the invert of the pipe appears to be approximately 2-3 feet below the bottom of the channel.

Efflorescence and delamination near the waterline

- The structure should be isolated from the creek during sediment removal to allow for dewatering. A minimum clearance of 3-4 feet is recommended for a sheet pile cofferdam, if that is the selected method of isolation.

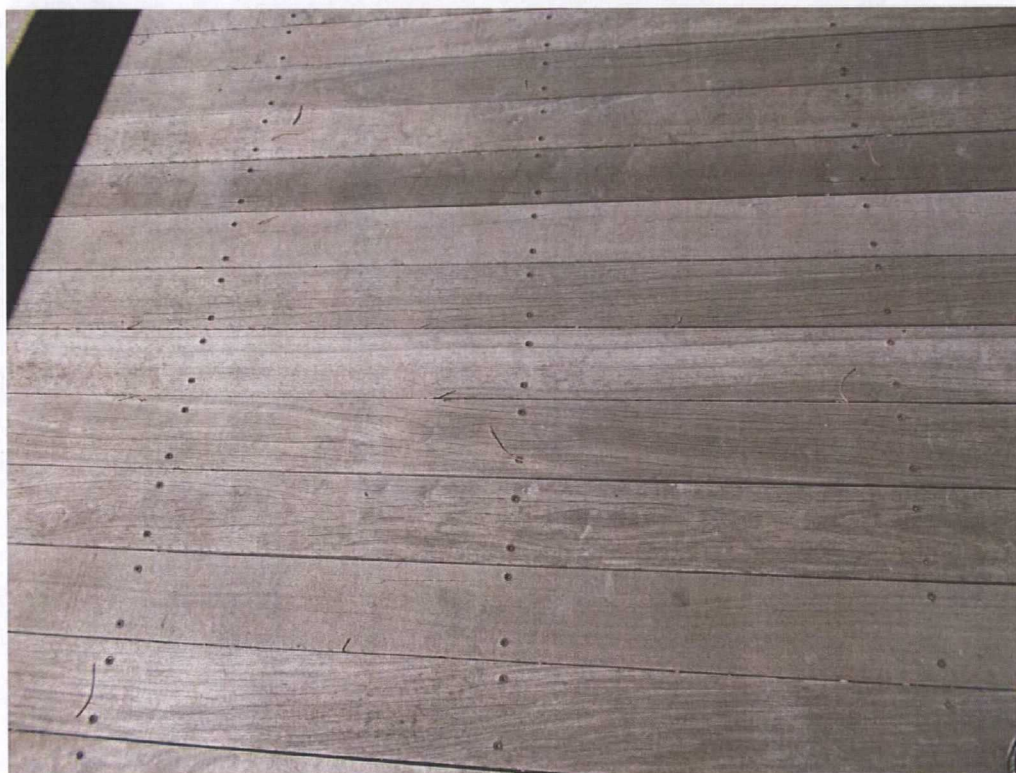
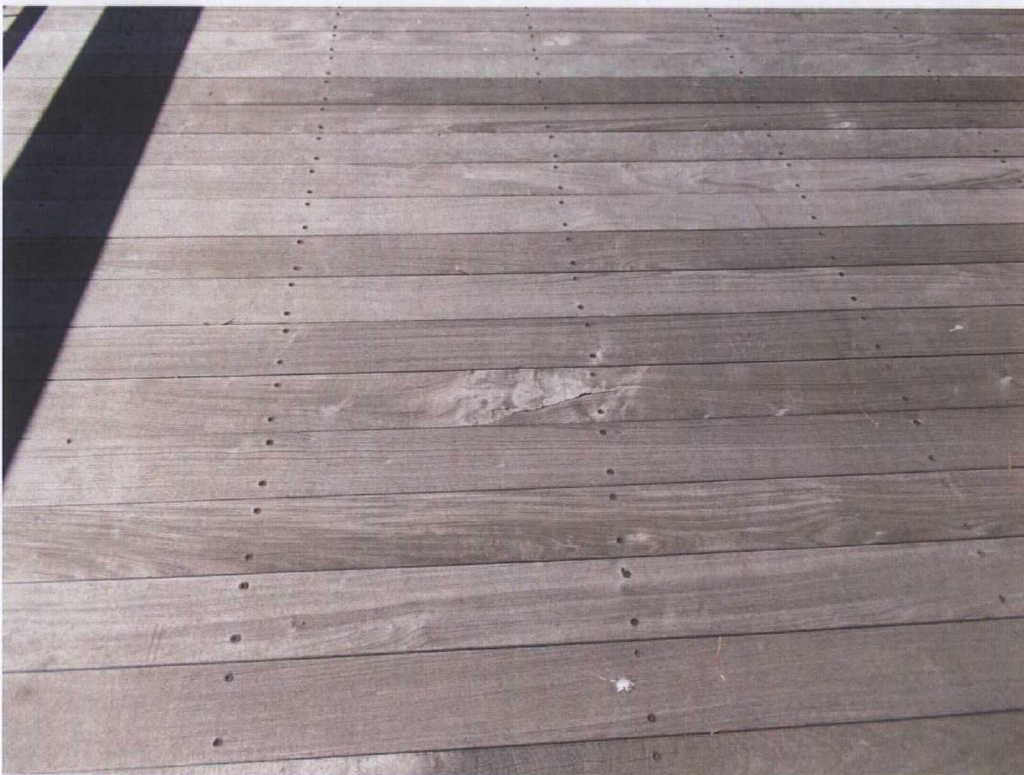
- The timber decking is weathered and has minor splitting over most of its area.
- Field stone riprap is in place around both abutments.
- The concrete sidewalk connecting to the boardwalk in the southeast is undermined approximately 2" and has cracking near its end.

Weathering and splitting of timber decking

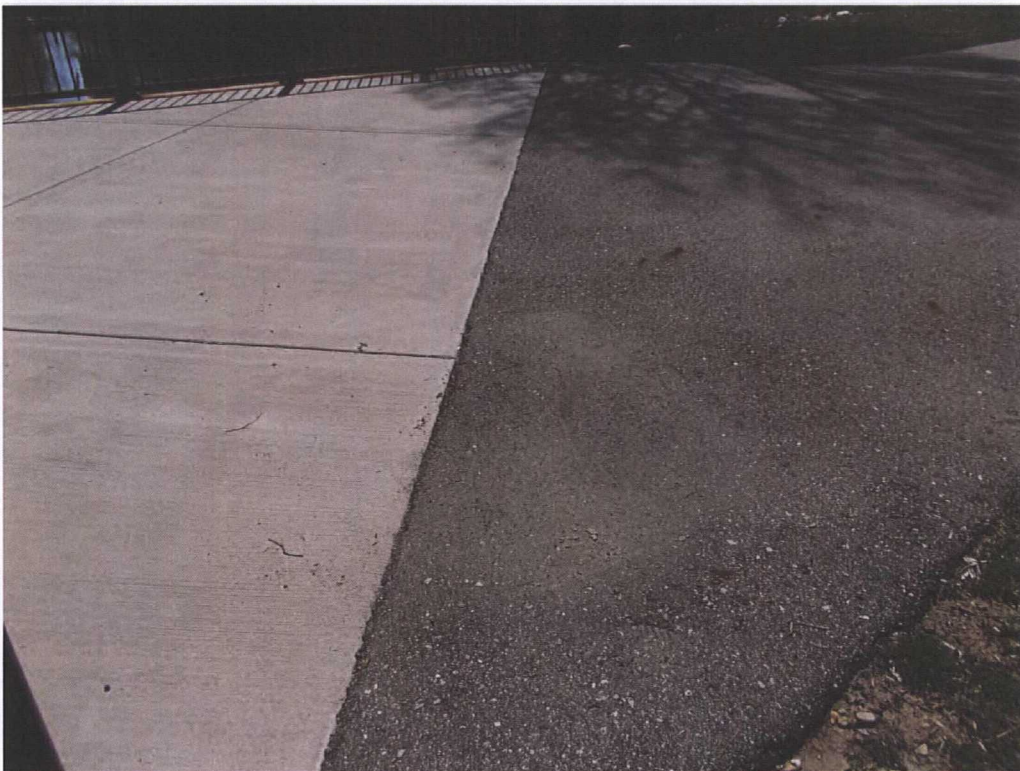
- Brush growth is encroaching on the southeast quadrant of the structure.
- The asphalt/concrete joint on the west approach is opening slightly. The asphalt has an isolated area of edge cracking in the southwest.

Separation along asphalt/concrete joint

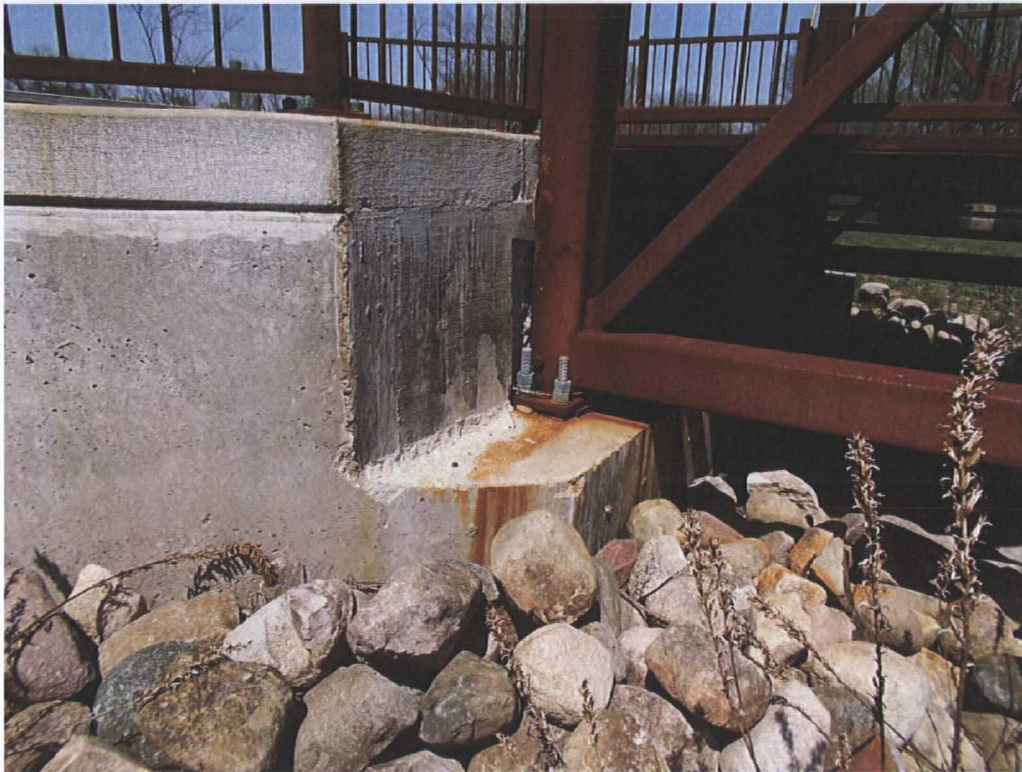
- The west backwall appears to have been sawcut/chipped to allow setting of the steel structure.
- Minor to moderate slope erosion was noted in the southwest.

Notched area of west backwall

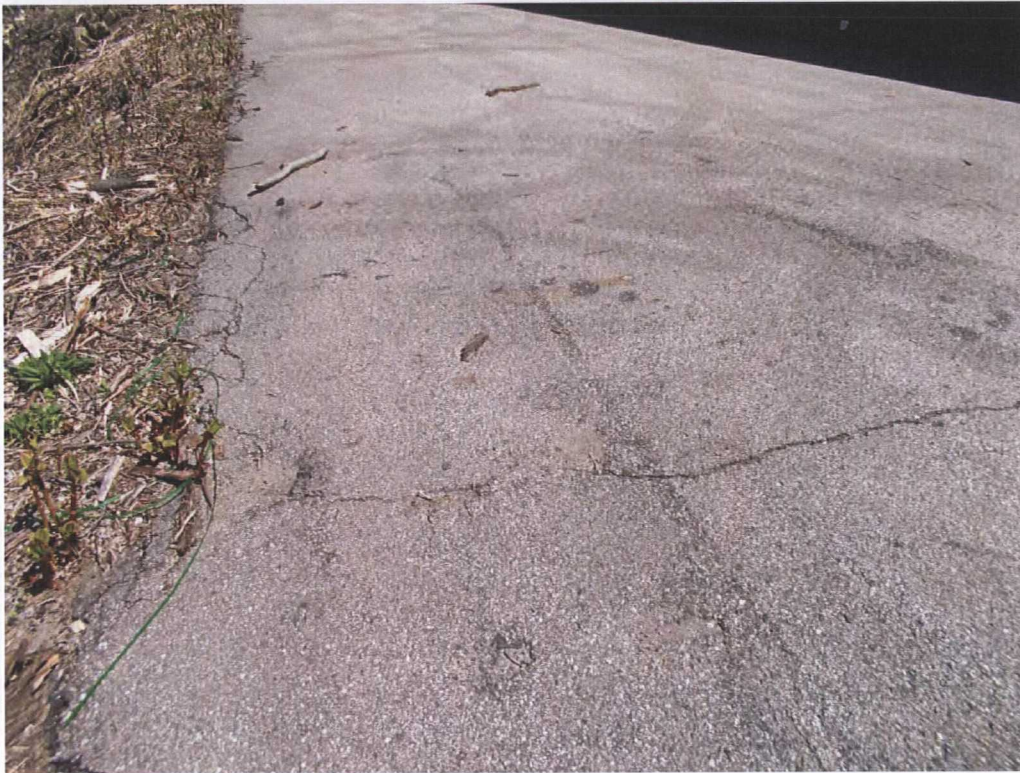
- The asphalt pavement is in fair to poor condition with cracking throughout, some of which has vegetation growth.
- Severe edge cracking and spalling was noted.
- Several areas of settlement and alligator cracking were noted.
- There is a concrete bumper at a commercial dumpster near the north end of the pavement area.

Edge cracking and random cracking in pavement

- Repair or replace damaged areas of pavement as required.

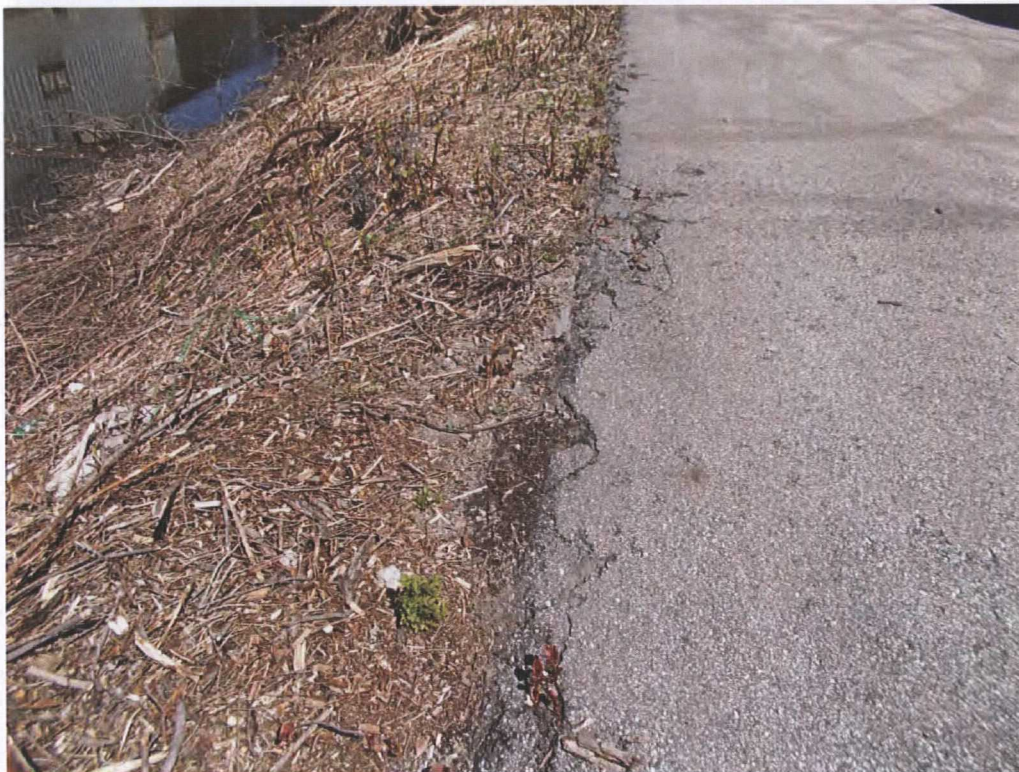
Edge cracking and spalling
